Limited Investigation of Indoor Air Quality and Mould Growth

Emmerson Hall
31 University Avenue, Wolfville, Nova Scotia

October 11, 2022

Pinchin File: 312422

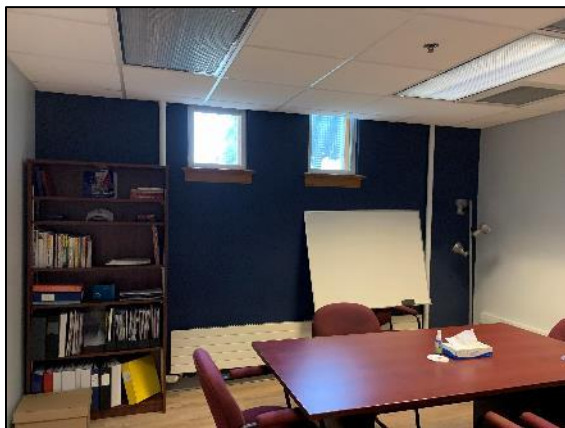
Photo 1 - View of east wall.

Elevated moisture readings, water damage and mould growth were observed on the east and south walls. The walls are the concrete foundation, partially below grade. Elevated moisture readings were measured under the windows on the east wall and on half of the south wall, extending from the southeast corner towards the center of the wall. Approximately 20 ft² of elevated moisture readings were measured on the east wall, and approximately 30 ft² was measured on the south wall. Mould growth was observed on the pipe insulation under the heater on the east wall along with peeling paint. Efflorescence and bubbling paint were observed on the south wall in the southeast corner.

Water damage and mould growth was observed within the meeting room off Room 108 on the first floor of Emmerson Hall. Elevated moisture readings were measured on both the east and south walls. The walls are concrete foundation. The paint was observed to be delaminating suggesting water intrusion. Mould growth was observed on the pipe insulation under the heater on the east wall. Efflorescence was observed on the south wall in the southeast corner.

Mould growth in buildings can be a risk factor for adverse health effects.¹⁴ The mould growth found in this investigation should be remediated as soon as possible following currently accepted procedures. Pinchin recommends that mould remediation follow the procedures set by the Canadian Construction Association (CCA).¹⁵ The work should be performed by a contractor with appropriate training, experience and insurance coverage. Ensure that remaining building materials are dry prior to reinstating mould-susceptible finishes, to prevent future mould growth.

1. Communicate the findings of this report to the occupants and staff.
2. Consider any necessary steps for interim risk management.
3. All source(s) of water infiltration should be identified and repaired to prevent further water damage and potential future mould growth. Consideration should be given into having a building envelope assessment conducted to ensure the cause of the water infiltration along the east and south walls is properly identified and repaired.
4. Remove and replace the mould-impacted pipe insulation following CCA Level 1 mould remediation methods.
5. Implement drying procedures as necessary. Ensure all surfaces are dry before installation of new finishes.

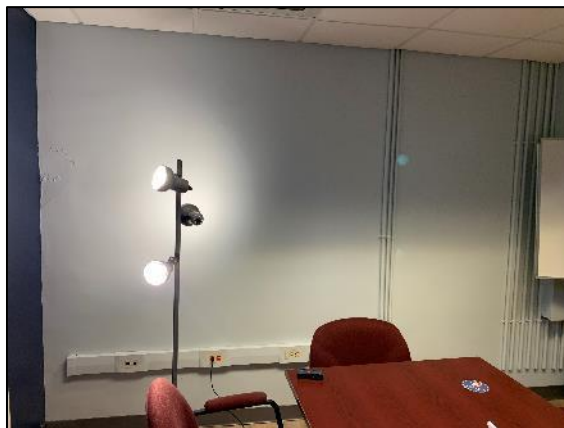
Photo 2 - View of south wall.

The water damage, mould growth and wet materials identified in this investigation (Room 108 – B) was likely caused by the drain observed on the other side of the exterior south wall.

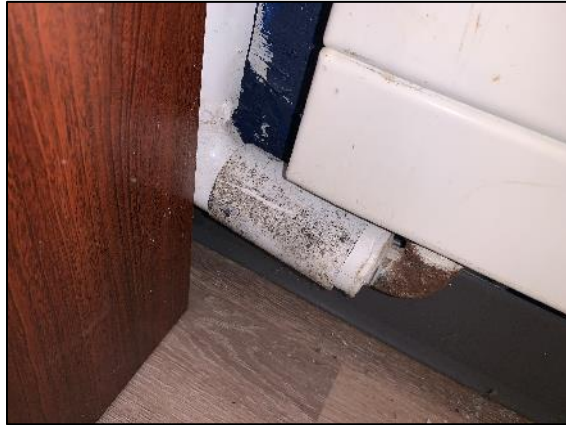
Photo 3 - View of mould growth on the pipe insulation.

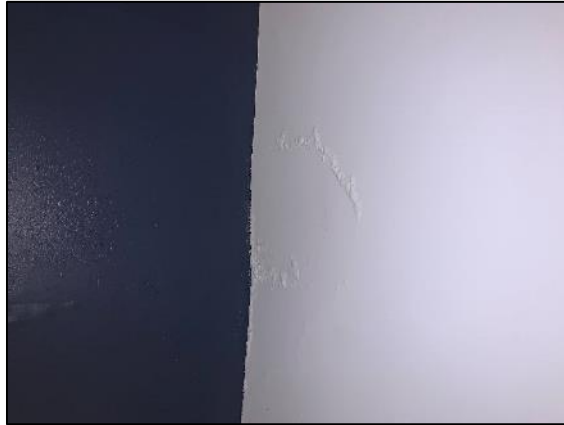
Photo 4 - View of bubbling paint and efflorescence on the south wall.

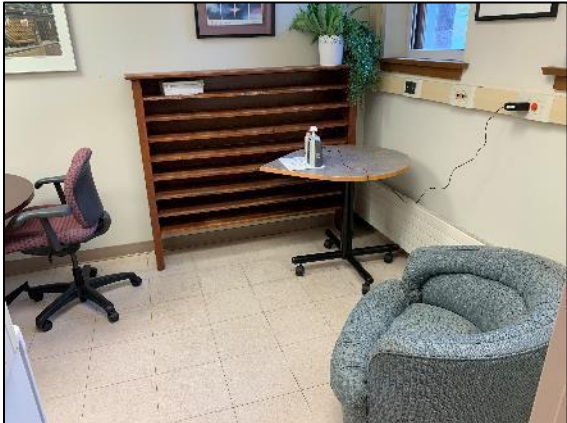
<p>Photo 5 - View of datalogging location.</p>

Mould growth and water damage were not observed. Elevated moisture readings were not measured.

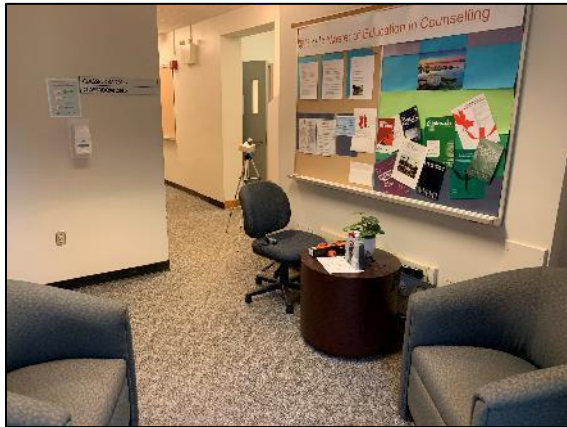
Photo 6 - General view of area.

Mould growth and water damage were not observed. Elevated moisture readings were not measured.

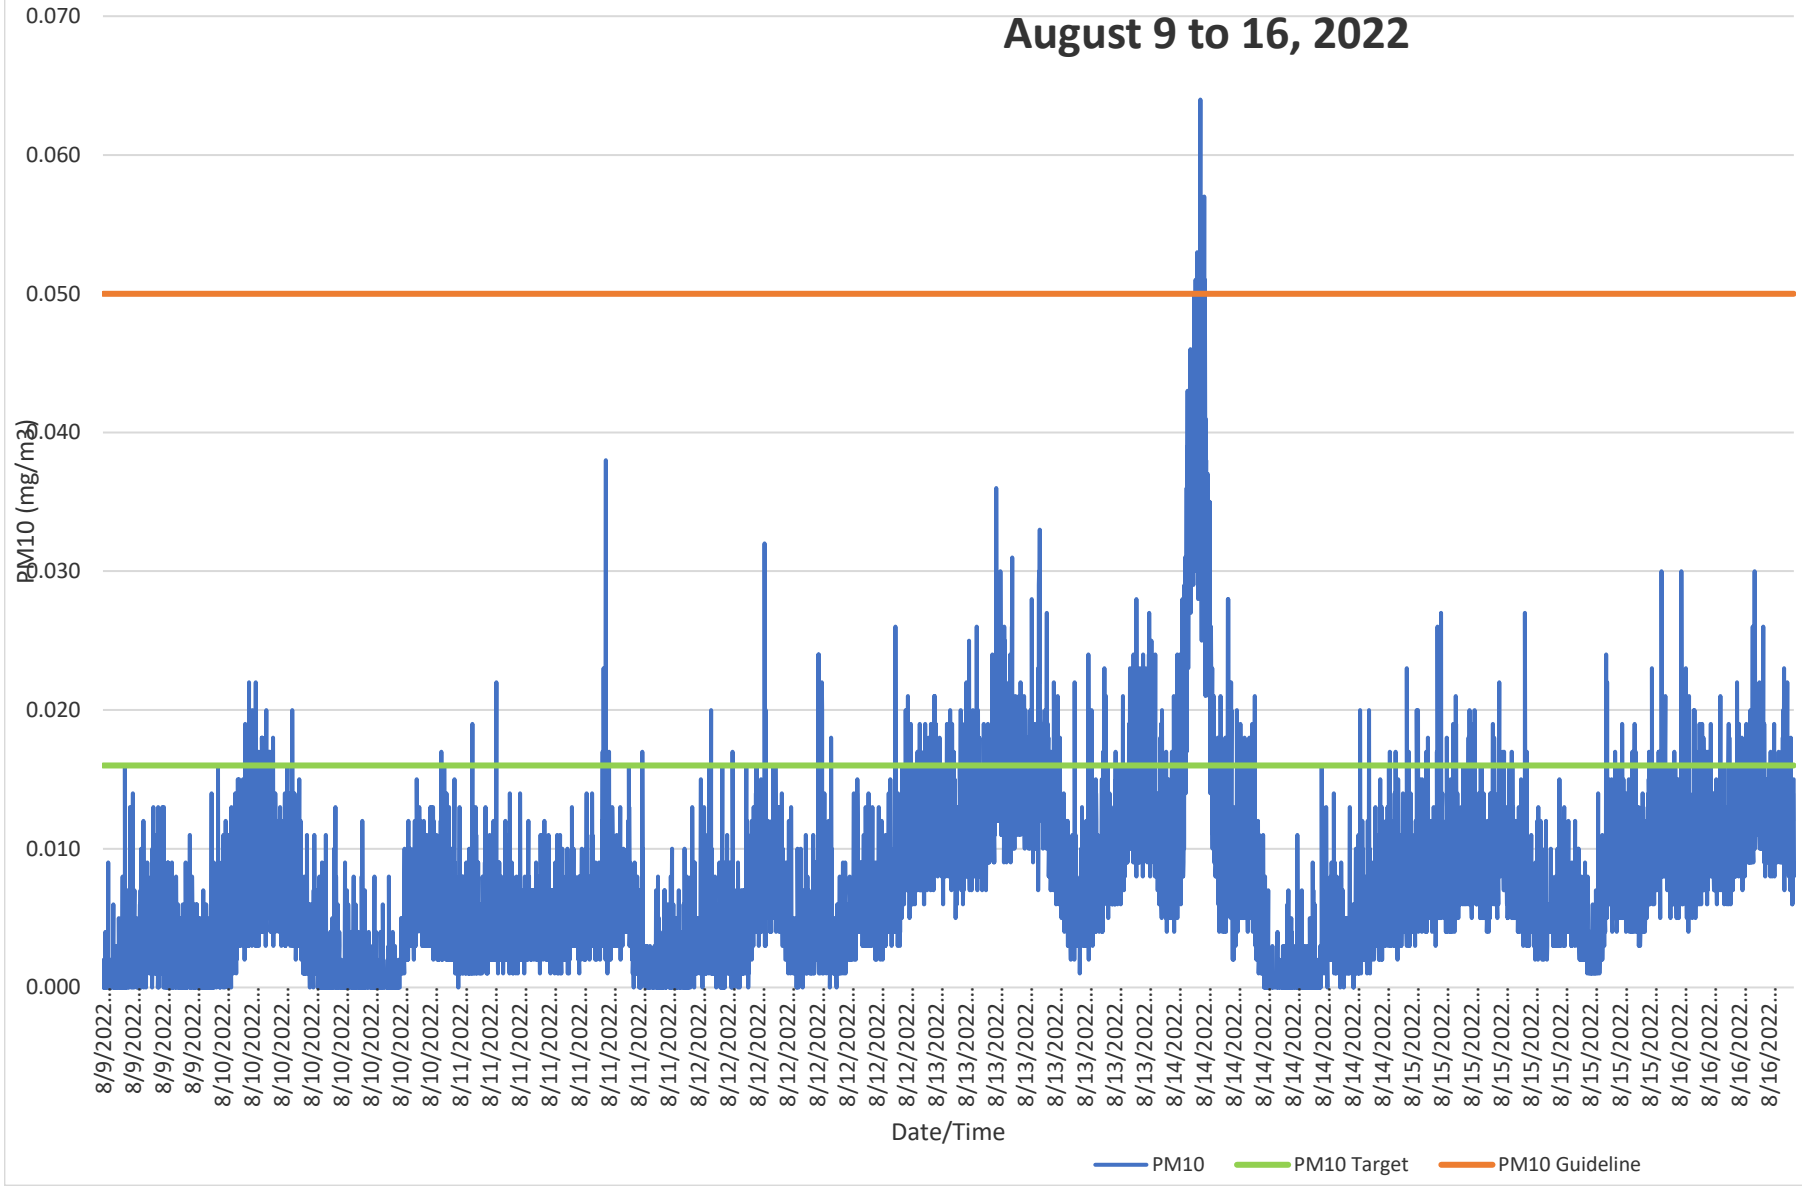
PM10 - First Floor Area 102
Emmerson Hall, 31 University Avenue, Wolfville, Nova Scotia
August 9 to 16, 2022

The indoor spot measurements of airborne dust (PM₁₀, particles less than 10 micrometres in diameter) ranged from 0.001 to 0.016 milligrams per cubic metre (mg/m³) and averaged 0.005 mg/m³. The outdoor concentrations averaged 0.005 mg/m³. The datalogging completed within First Floor Area 102 ranged from less than the detection limit of the instrument of (<0.001 mg/m³) to 0.064 mg/m³ and averaged 0.007 mg/m³. The datalogging completed within the Second Floor Hallway ranged from <0.001 to 0.141 mg/m³ and averaged 0.009 mg/m³. For reference, US EPA research indicates that the PM₁₀ concentrations measured in commercial buildings are generally less than 0.016 mg/m³. Pinchin considers this to be a target concentration; where most measurements fall within this range, complaints are not expected. ASHRAE provides a guideline of 0.050 mg/m³ but suggests that if the majority of concentrations are at this level, dust deposition may be undesirable. The PM₁₀ concentrations in this building generally fell within the range typically measured in commercial buildings with exceptions during August 9th at 20:44,

and August 12th at 09:00 that exceeded the 0.050 mg/m³. Both datalogging locations averaged below the target of 0.016 mg/m³.

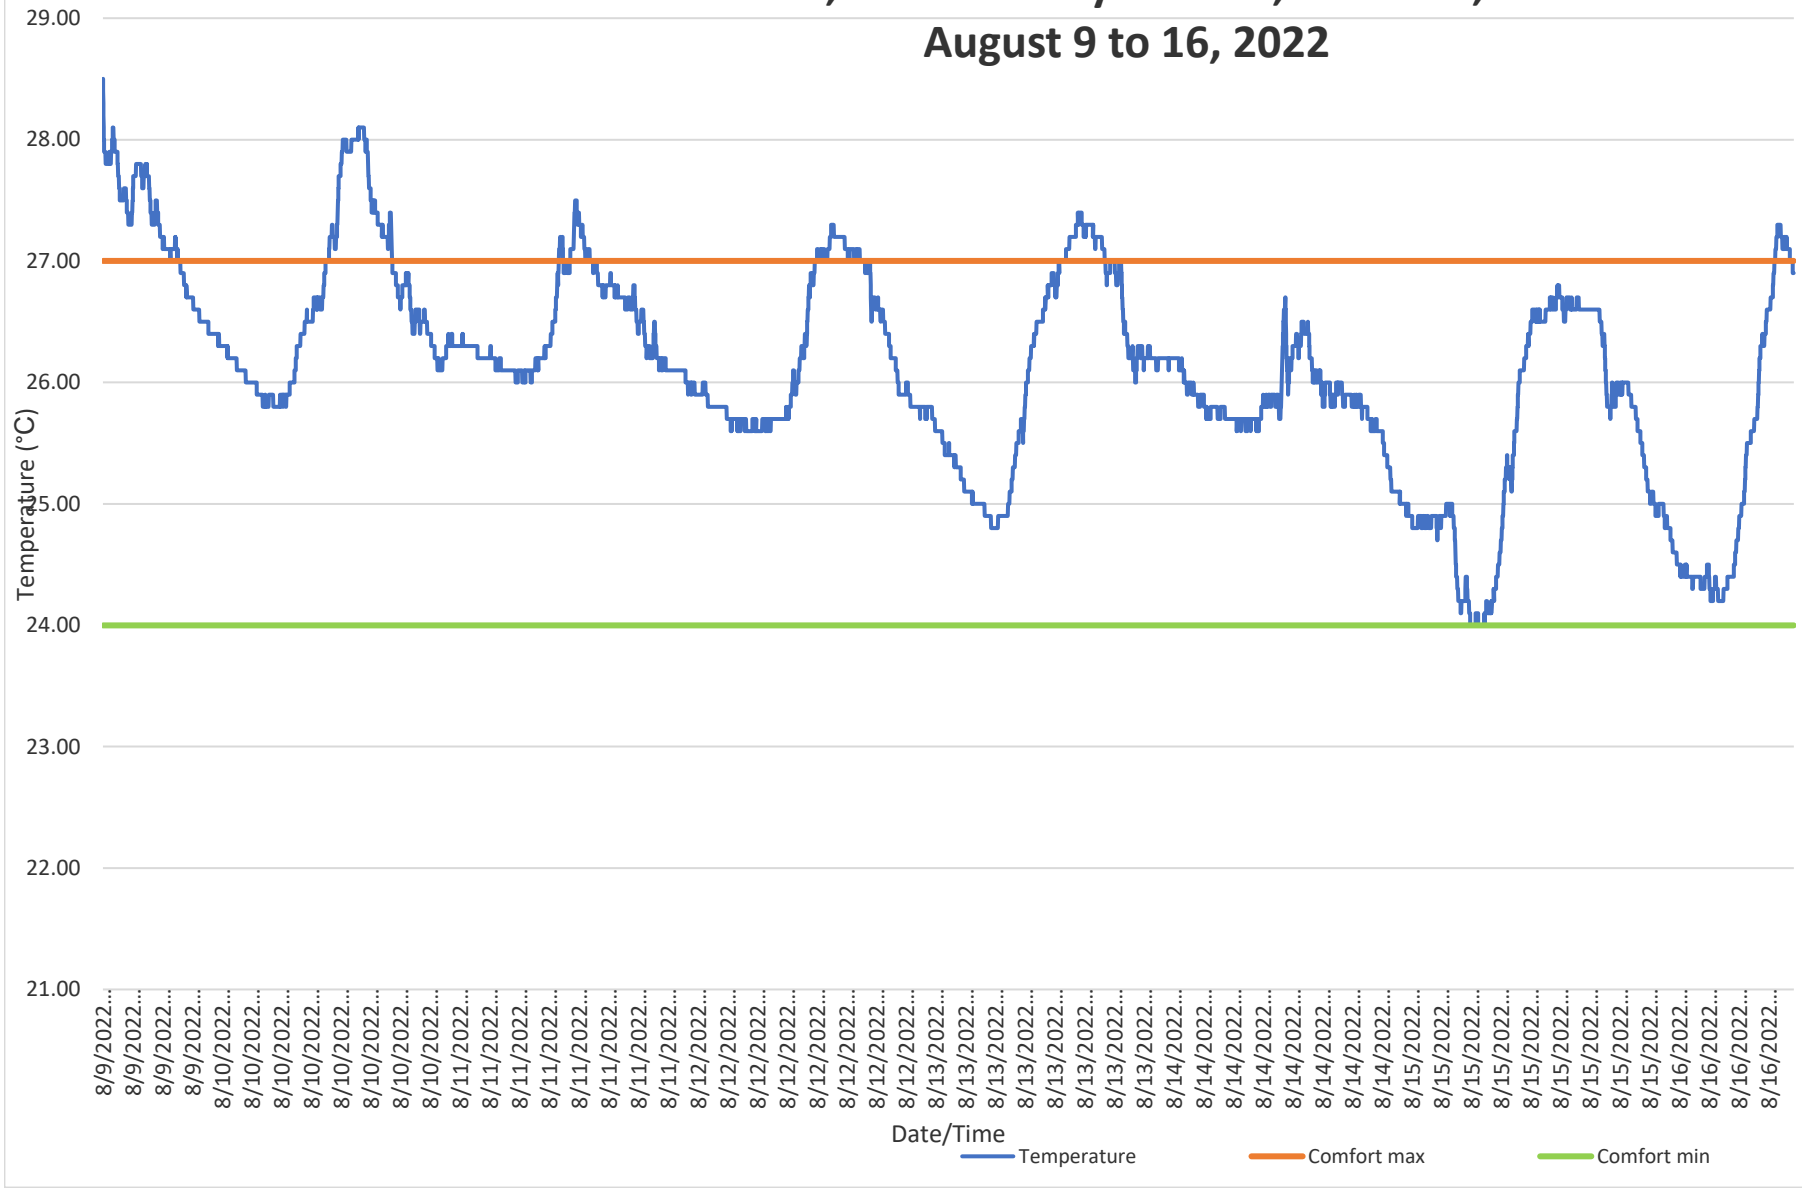
Temperature - First Floor Area 102

The indoor spot measurements of temperature ranged from 26.0 to 28.7 °C and averaged 27.1 °C. The outdoor temperature was 24.1 °C. The datalogging completed within First Floor Area 102 ranged from 24.0 to 28.5 °C and averaged 26.1 °C. The datalogging completed within the Second Floor Hallway ranged from 26.0 to 30.3 °C and averaged 28.4 °C. The temperatures generally were outside the recommended comfort ranges for office environments, of 24 to 27 °C for typical summer dress. The majority of the temperatures measured were above the recommended summer comfort range. Temperature preferences are, however, very personal and these conditions might be acceptable to the occupants.

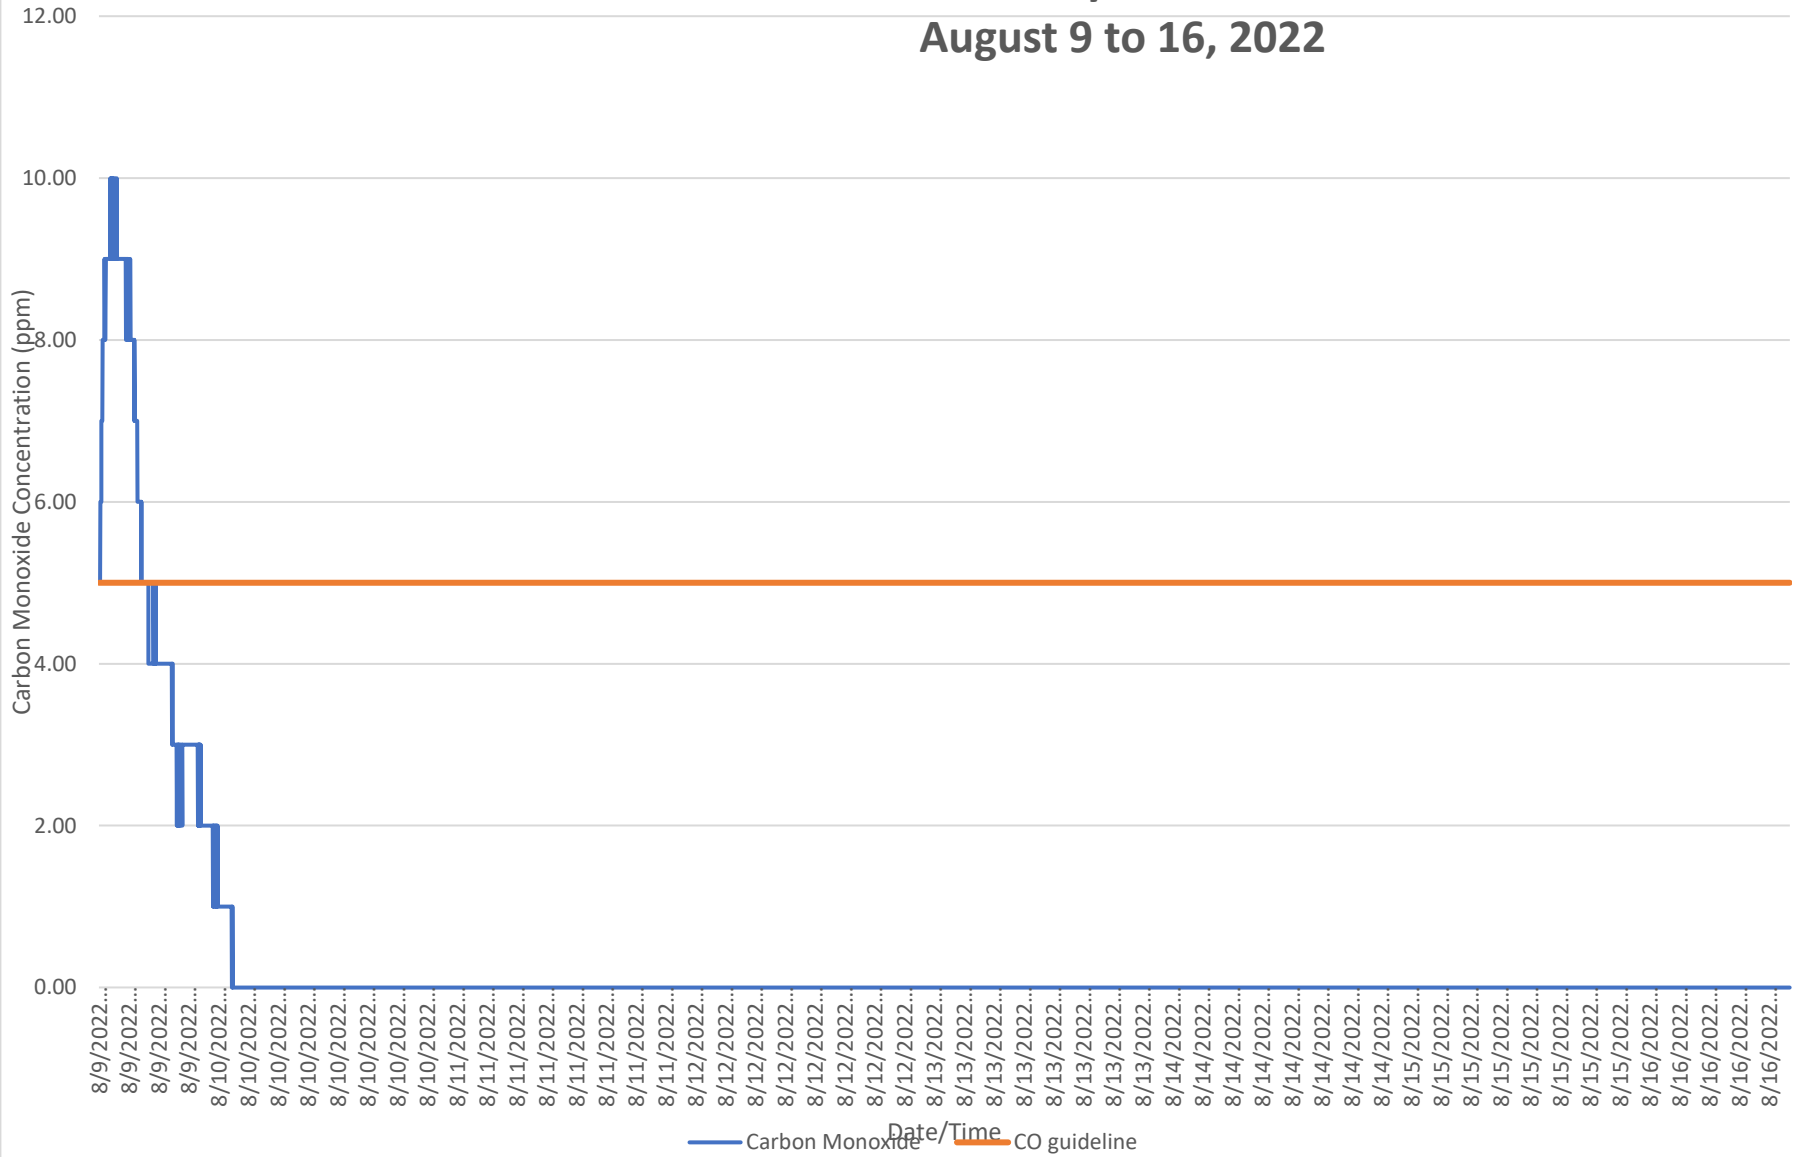
Carbon Monoxide - Second Floor Hallway Emmerson Hall, 31 University Avenue, Wolfville, Nova Scotia August 9 to 16, 2022

measurements collected during the datalogging period in the Second Floor Hallway were above 5 ppm from 13:54 – 17:59 on August 9, 2022. CO measurements collected during the remainder of the datalogging period were less than 5 ppm.

During the datalogging in the Second Floor Hallway, the carbon monoxide exceeded the guideline of 5ppm at the beginning of the datalogging period, but was below the guideline within 6 hours and stayed below the guideline for the remainder of the datalogging period. PM_{10} concentrations averaged 0.009 mg/m^3 , below the target of 16 mg/m^3 and the guidelines of 0.050 mg/m^3 , although there were a few exceedances of the guideline briefly on August 12th and August 14th. TVOC concentrations were above the US EPA recommendation in the Second Floor Hallway from 19:08 - 23:43 on August 11th, 2022. All other TVOC concentration were below 400 ppb.
