CSR GeoSurveys Limited

Ground Penetrating Radar Investigation Wolfville, Nova Scotia

CSR Project Number: 2367
Date: January 09, 2024

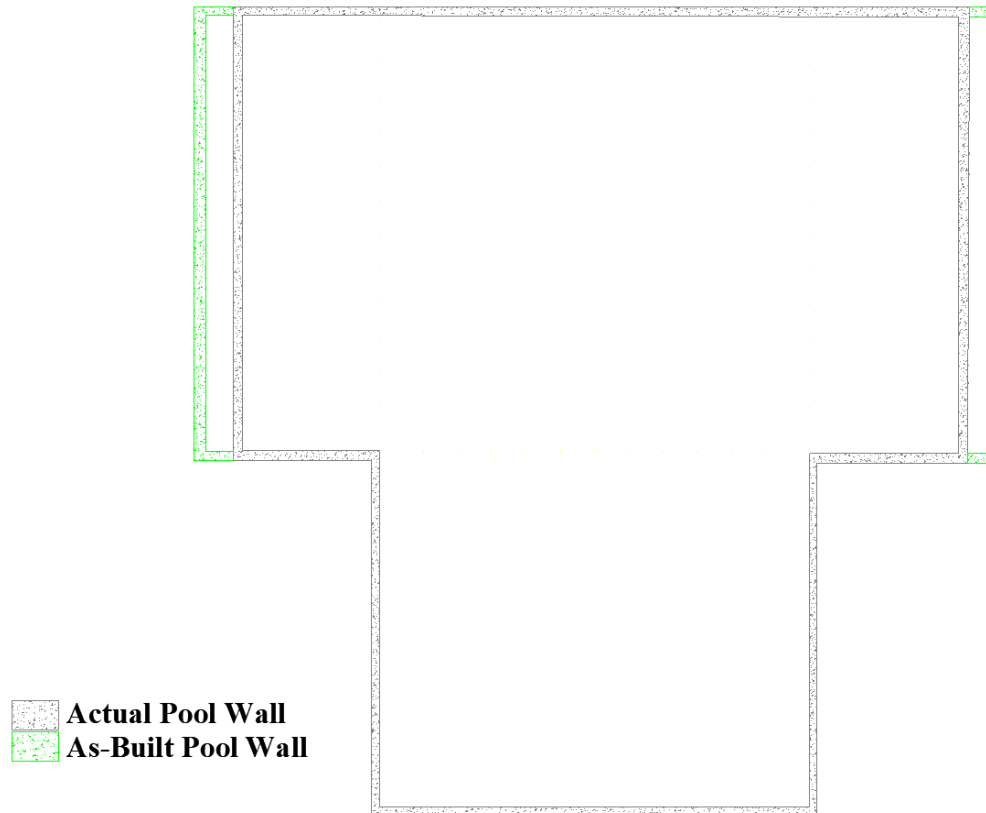
As shown in Figure 4.1.1 measurements obtained on-site show that the widest section of the pool footprint measures ~22.5 metres (~73' 10") wide east/west. The deeper section of the pool running north south is still centered and measures ~25 metres.

The variation of the footprint may indicate a crawl or mechanical space may be present beyond the pool walls, the pool was not constructed to specification, or the pool was modified since the original construction.

Figure 4.1.1 – Sketch showing the approximate variation between the as-built footprint (green) and measured footprint (grey)

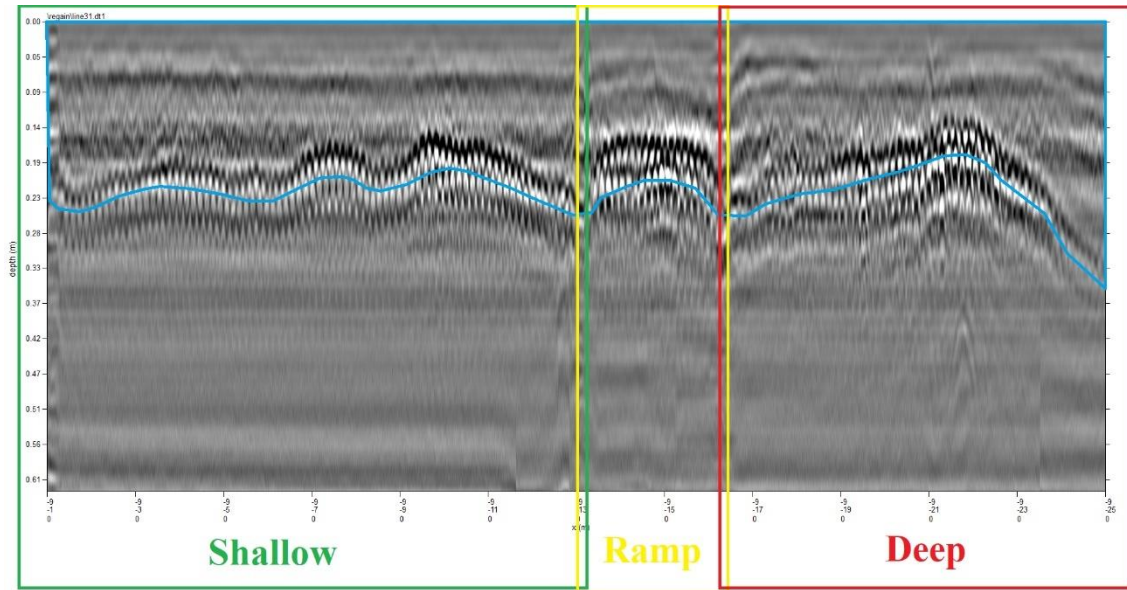
The thicker sections of the concrete slab appear to be located in the deep end of the pool and the northeastern shallow end, potentially associated to recent alterations. The thinner sections of the pool floor are found primarily on the northwestern shallow section and near the drains in the deep section, please see Figures 4.1.2 and 4.1.3.

It is possible the variations in the estimated slab thickness from the as-builts is related to previous repairs, installation of tiles, variations in velocity, leveling pours, and error in the estimates due to the clarity of the identified horizon.

Figure 4.1.2 – Example radargram running north/south through the center east portion of the pool showing the approximate bottom of slab in blue.

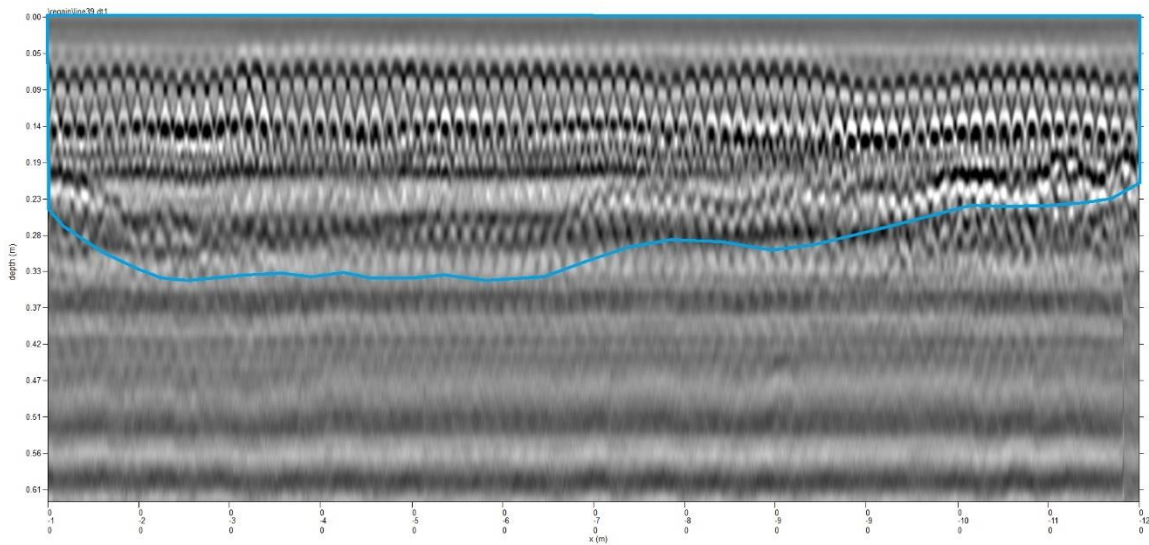
Figure 4.1.3 – Example radargram running north/south over the eastern shallow portion of the pool showing the approximate bottom of slab in blue.

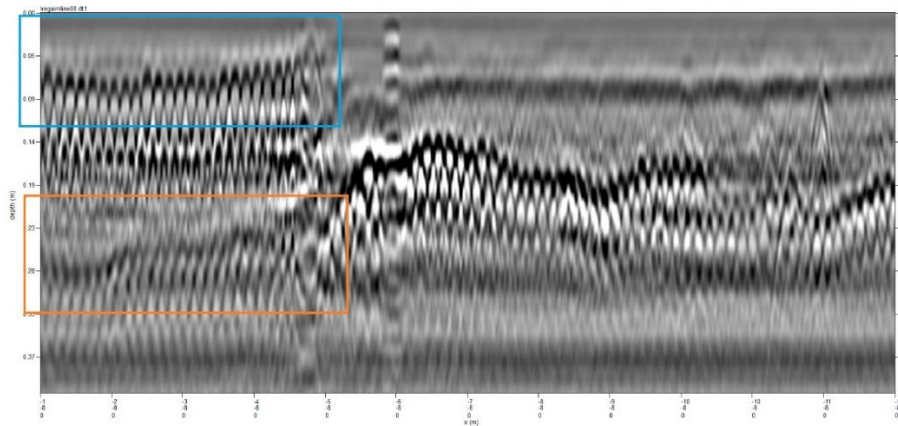
The GPR data appears to indicate that a second layer of welded wire mesh is present throughout the eastern shallow section of the pool. Determining the exact location and coverage of the second layer is challenging as the shallower layer reflects the majority of the signal produced by the GPR system.

While technicians from CSR GeoSurveys were on-site a conversation was had with the facility staff indicating the eastern shallow section of the pool had recently been modified to be shallower. It is possible that the recent modifications are the cause of the variation in this area.

Figure 4.1.4 – Example radargram running east/west through the shallow section of the pool, showing the double layer of welded wire mesh in orange (lower) and blue (upper).

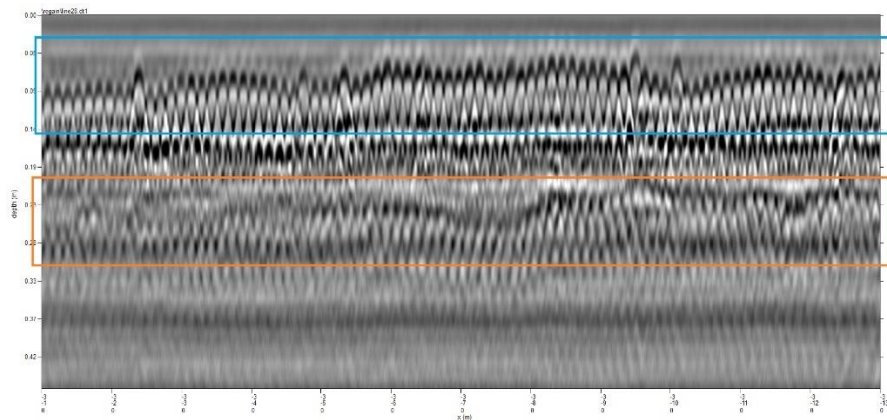
Figure 4.1.5 – Example radargram running north/south through the eastern shallow section of the pool, showing the double layer of welded wire mesh in orange (lower) and blue (upper).

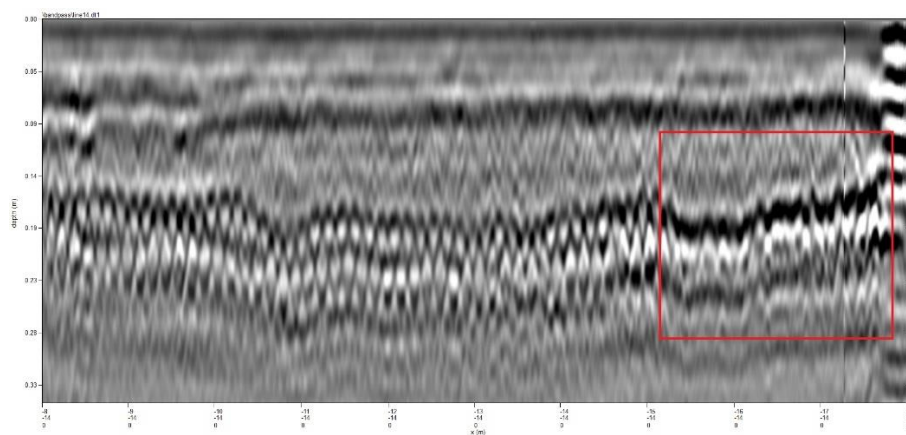
Review of the data collected showed several areas with a high amplitude response at the interface between the concrete and base materials. These areas include the northwestern corner, western corner between the deep and shallow areas of the pool, the eastern corner of the deep and shallow ends of the pool, and in the immediate proximity of both drains located in the deep section of the pool.

In some areas where the high amplitude response was noted it appeared to correspond with the depth of the welded wire mesh while other areas showed no indication of welded wire mesh. This potentially indicates that the wire mesh is either immediately on the bottom of the slab or not within the slab. This could be related to errors at the time of construction or indicate that the bottom of the slab has begun to spall, potentially related to the oxidation of the welded wire mesh.

Figure 4.2.1 – Example radargram showing potential sub-slab voiding in red.

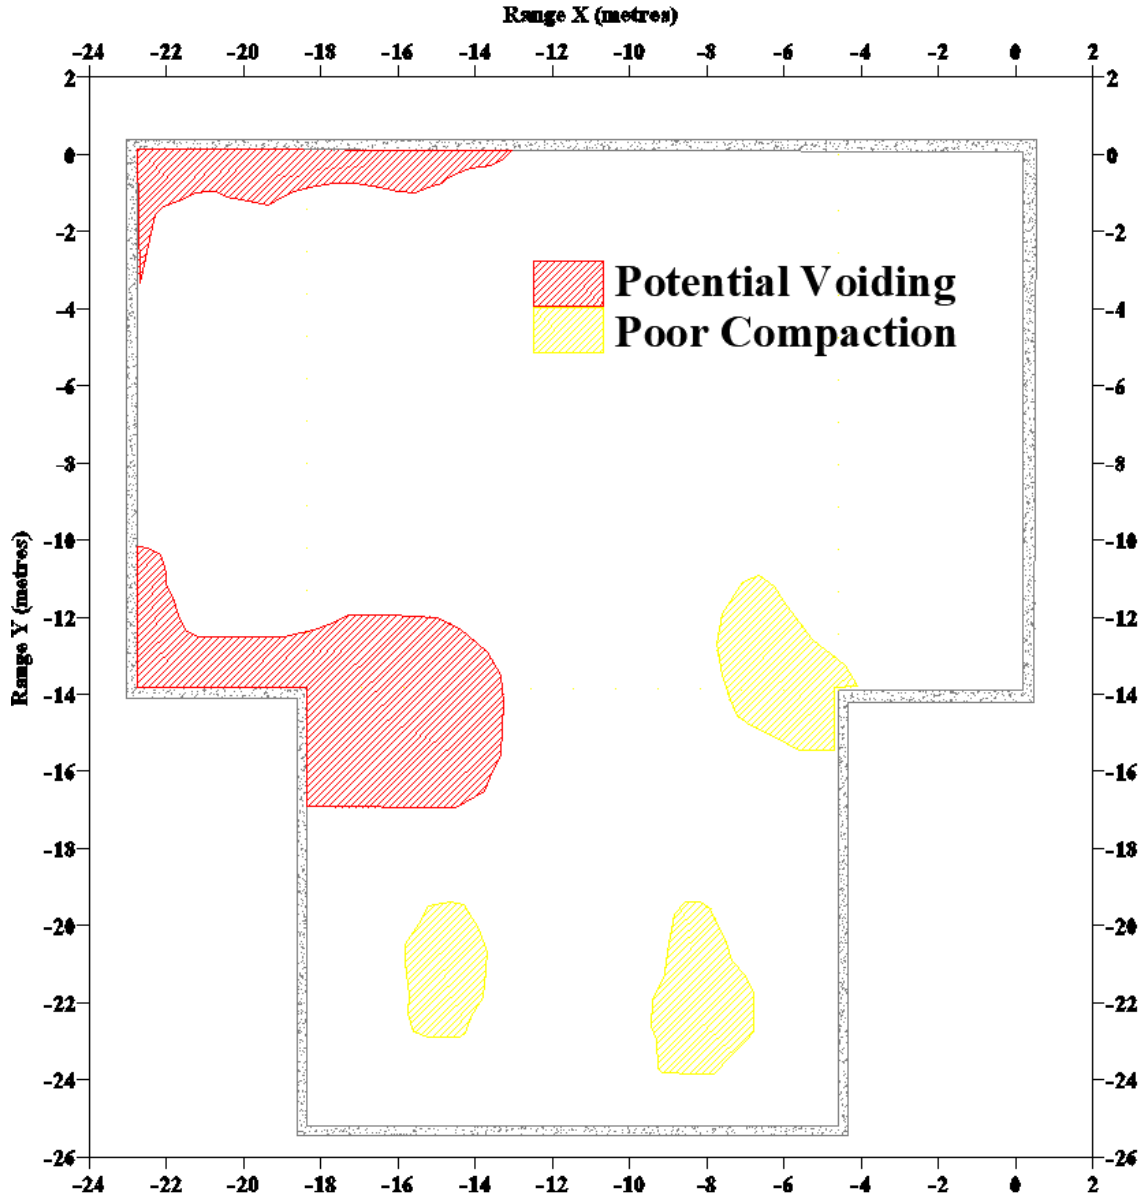
The variation of amplitude noted in the northwestern corner of the pool and the western corner between the deep and shallow ends are larger than the other areas. These areas are thought to have the highest probability of being associated with sub-slab voiding. The areas noted adjacent to the drains and on the eastern corner between the deep and shallow sections have a lower amplitude response and are potentially associated with poor compaction of base materials or minor voiding.

Figure 4.2.2 – Plot showing approximate locations of potential sub-slab voiding and poorly compacted base materials.

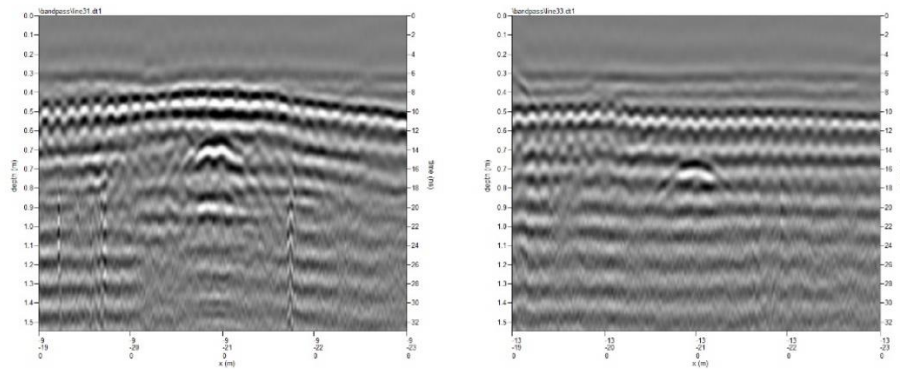
One of the features appears to run east/west between the two drains in the deep section of the pool. A single hyperbola is noted on 4 parallel lines of data (Figure 4.3.1) which strongly indicates the potential of at least a single utility in the area approximately 3-4 metres long.

Figure 4.3.1 – Parallel radargrams showing the hyperbola associated with the presumed east/west utility in the area of the pool drains.

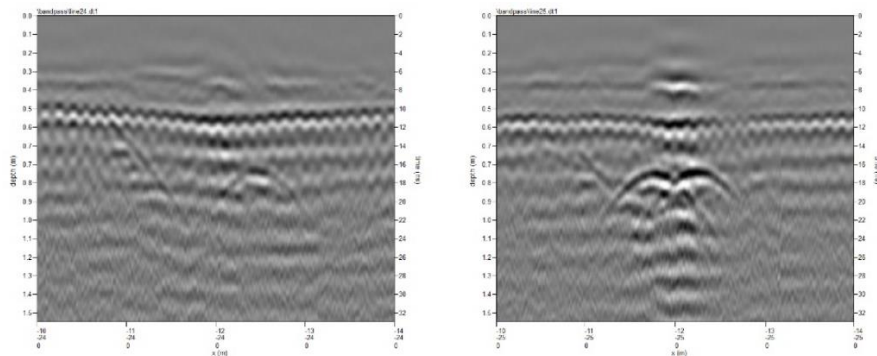
The other feature is represented by two adjacent hyperbolas on a single radargram with the adjacent parallel line showing only a single hyperbola (Figure 4.3.2). This feature appears to extend approximately 1-1.5 metres in a north/south orientation beginning on the southern edge of the pool. It is possible the feature continues and GPR was unable to properly image it.

Figure 4.3.2 – Parallel radargrams showing the hyperbola associated with the presumed north/south utilities running from the southern edge of the pool.

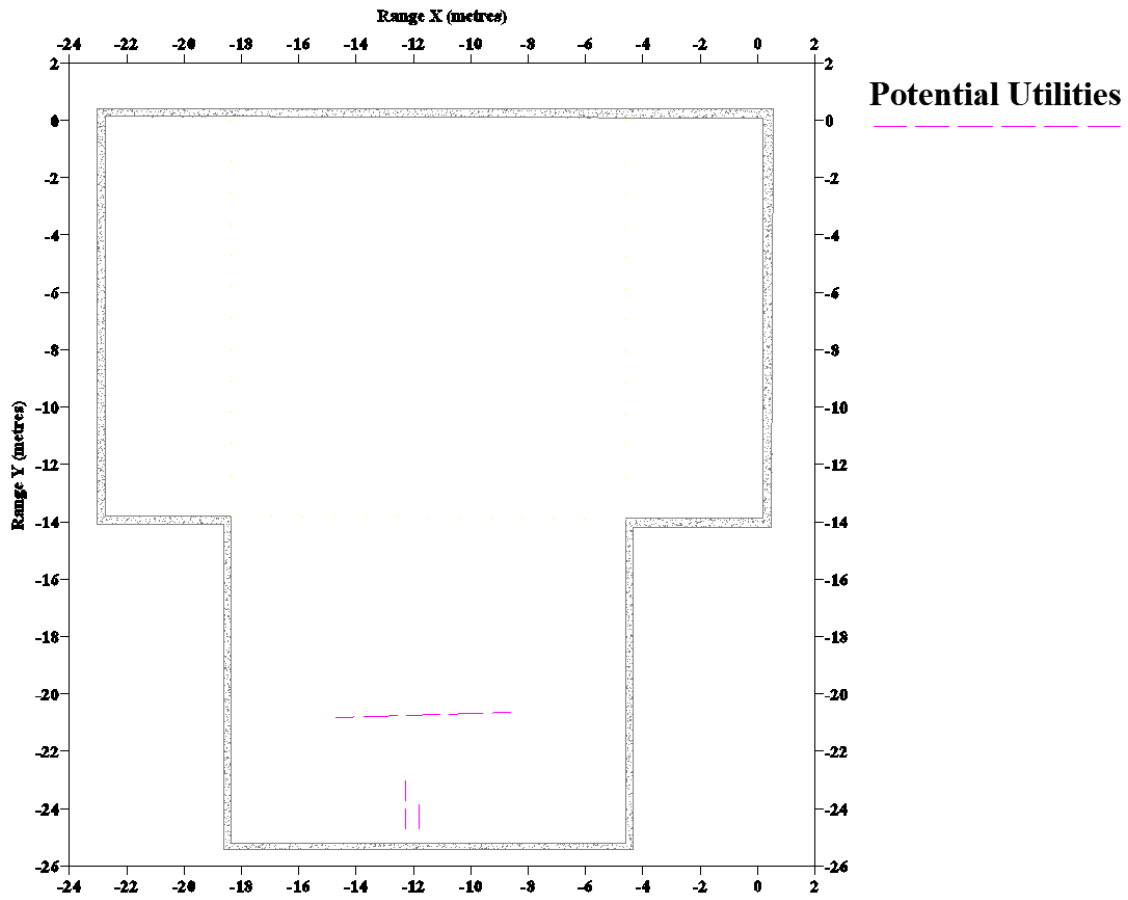
Utilities buried under a concrete slab often provide the path of least resistance when water movement is present in the area. This will often result in sub-slab voiding or settlement of materials along the pathway of the utilities. This does not appear to be the case for this investigation as no signatures clearly associated with potential sub-slab voiding are noted in the area of the potential buried utilities.

Figure 4.3.3 – Sketch showing the approximate locations of the potential buried utilities.
